CHEMICAL PROCESSORS, INC.
PIER 91

RCRA INSPECTION REPORT

Inspection Conducted
12-5-90

RCRA No.WAD009812917

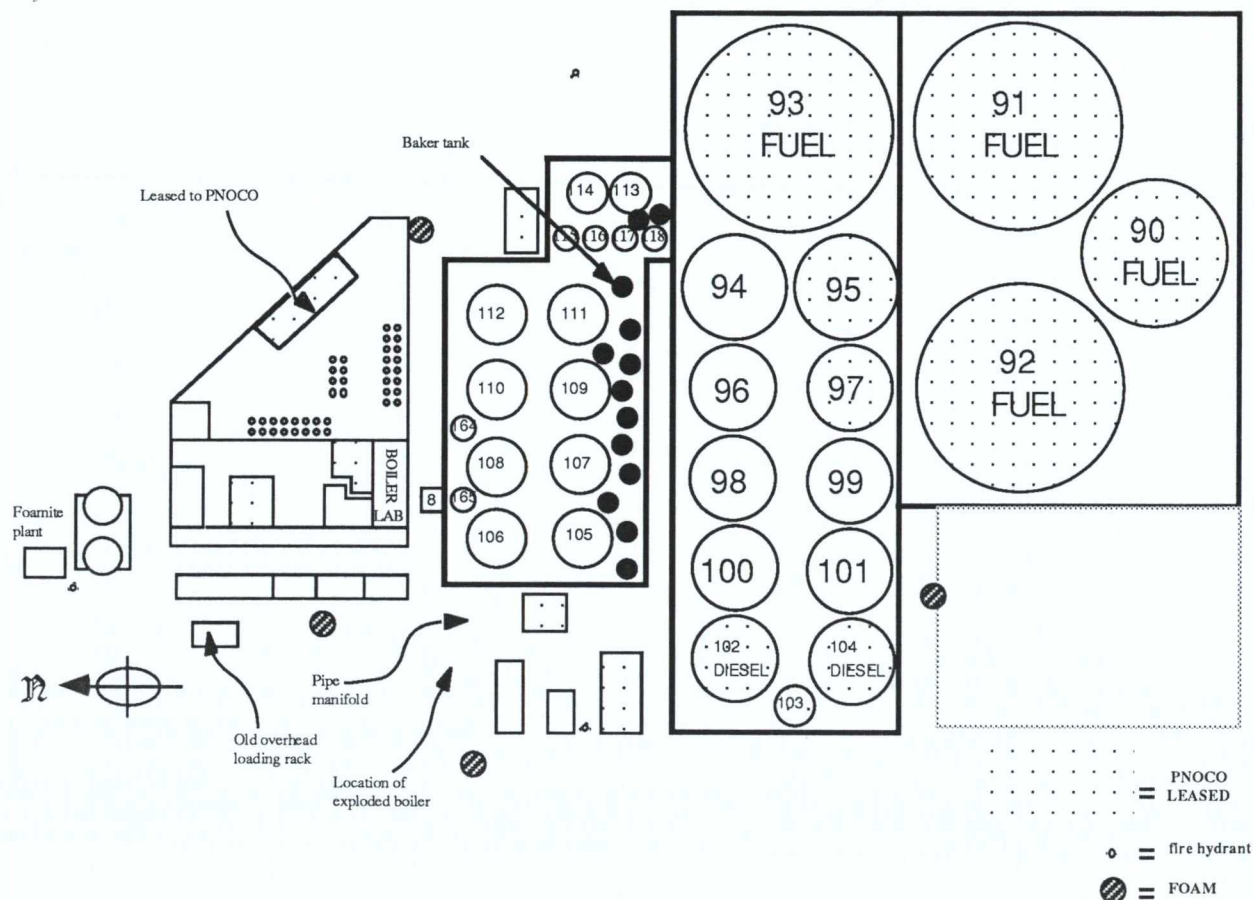
I toured the facility with Mr. Mathews, Mr. Atwood, and Ms. Harding. Beginning in the Administrative offices we moved in a counterclockwise direction around the plant (See diagram of the facility).
